# DYSNES

A Preliminary Site Study for a  
Primary Aluminum Plant in Eyjafjörður

Almenna verkfræðistofan hf  
Verkfræðistofa Norðurlands ehf  
Rafhönnun hf  
March 2003

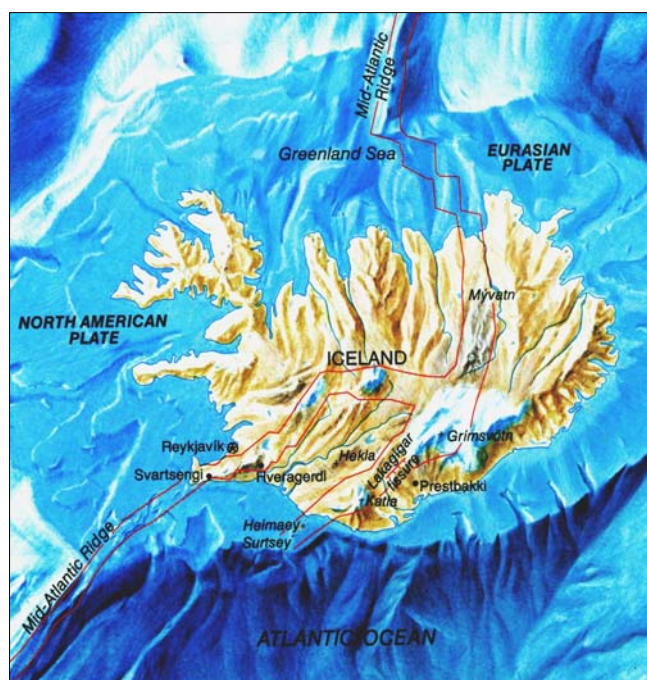
Fig 5: Plate boundaries and volcanic zone through Iceland (source: National Geographic).

Iceland is a volcanic island, located on the crest of the Atlantic ridge which also happens to be the plate boundary between two of the major plates that form the earth's crust (lithosphere), i.e. the North-American and Eurasian Plates. Between the two plates, a volcanic zone runs at a slant through Iceland heading NE from the Reykjanes peninsula in the southwest towards lake Mývatn and Axarfjörður in the north. The volcanic zone is characterized by young formations and active geothermal areas with volcanic activity and movement of the earth's crust. The movements result in earthquakes that are most intensive at their origin (epicenters), fading out with distance.

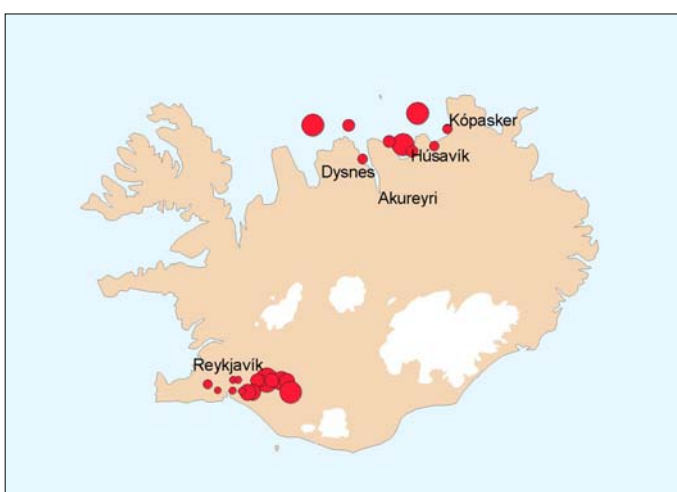
Fig 6: Origins of major earthquakes in Iceland since 1700. (Source: Páll Halldórsson 2002.)

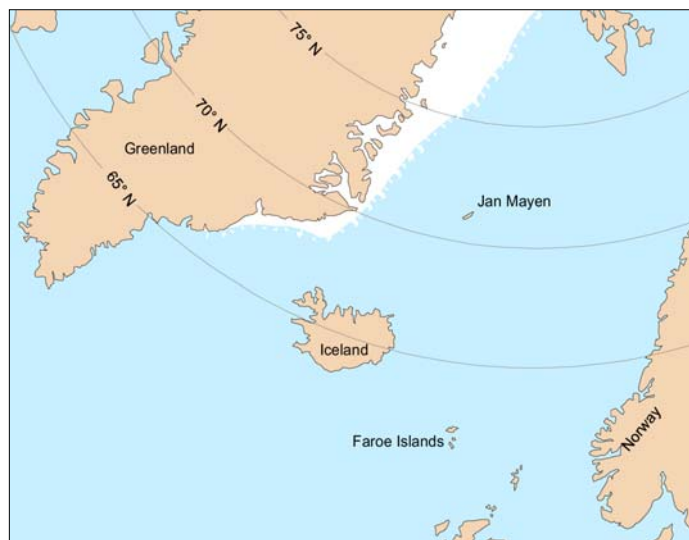
Fig 9: Median ice edge boundaries October 1, 1972-1982. (End of summer)

In Fig.9 and Fig.10 the median ice edge boundaries at the end of winter (June 1) and end of summer (October 1) for eleven years (1972-1982) are shown.

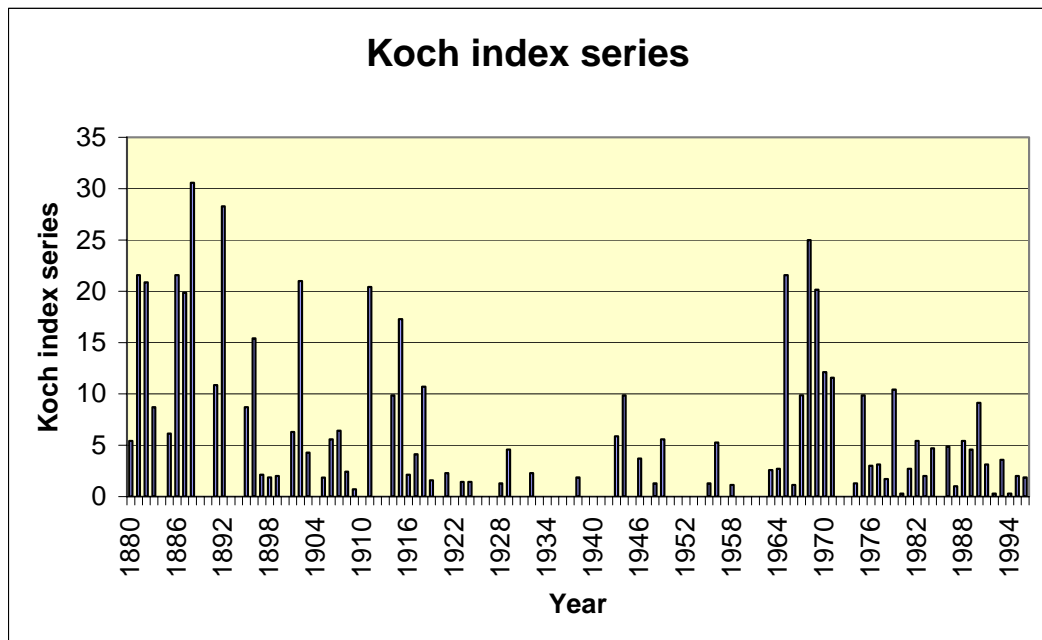
Fig 12: Changes in sea ice conditions off the coast at Iceland have been recorded for a long time according to a special sea ice index, the Koch-index which is a multiplication of weeks with sea ice and number of specified sections of the coast.

As can be seen from the so-called Koch index in Fig 12, the period from 1880 to 1920 was a period when sea ice was frequently seen off the coast of Iceland. Then there was a long, practically ice free period from 1920-1964. A new sea ice period was experienced from 1965-1971, when the ice was frequent and widespread. Since then, with the exception of 1979, sea ice off the coast of Iceland has been very moderate if there has been any at all.
